RE: Site Inspection, Jumbo Mining Company, Drum Mine, M/027/007,
Millard County, Utah

Date of Inspection: April 14, 1993
Time of Inspection: 1130 - 1530
Conditions: Cool, clear, light breeze
Participants: Dave Hartshorn, JMC; Rody Cox, BLM; Lowell Braxton,
Tom Mitchell & Wayne Hedberg, DOGM

Purpose of Inspection: Evaluation of current operational state and site
familiarization for DOGM management and legal counsel.

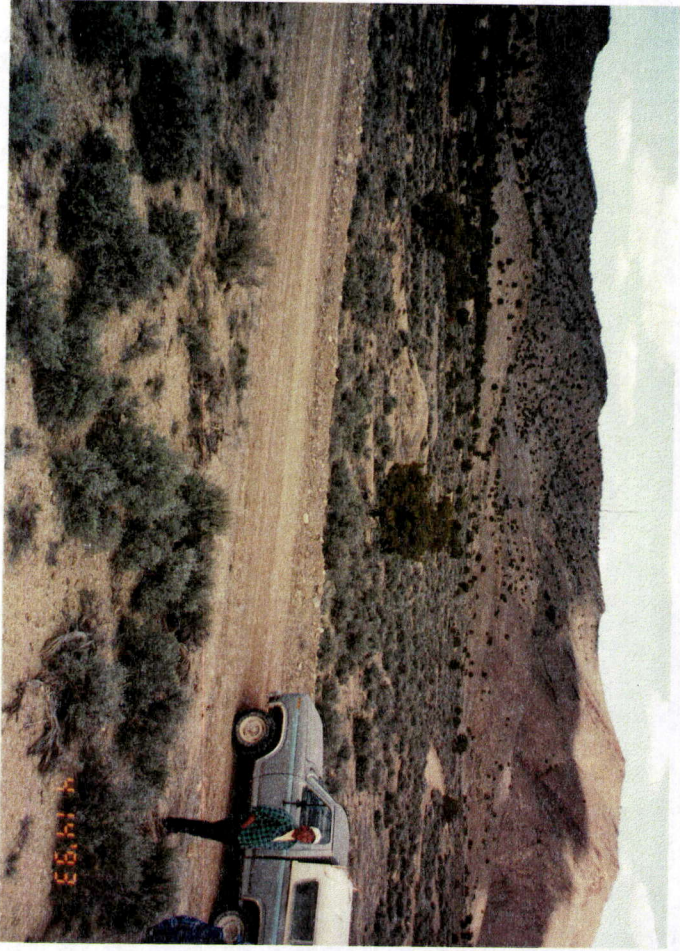
The reclaimed Monarch pit was our next stop. In 1991(?) this pit area was partially backfilled with wasterock, regraded and seeded. It is a dry, harsh site with a very coarse, rocky surface, minimal fines and no salvageable topsoil was applied/available for reclamation. Mr. Hartshorn indicated they tried to work a hydrosopic soil amendment into a portion of the reclaimed area a year ago. No observable increase in revegetative success has been noted. Some of the native shrubs are showing signs of growth again, poking through in areas of thinner wasterock cover. We did note some early growth of bunch grasses, rabbit brush and a few forbs on the site. Overall, the site shows very poor revegetative success. Some supplemental revegetation effort and additional regrading work may be necessary before the Division can consider releasing this site. An important factor in achieving some degree of reasonable revegetative success, may be to implement some control mechanism to minimize the indiscriminant grazing by domestic sheep in the area. Temporary fencing of the reclaimed areas may be one possible option.

Monarch test pit (overview)

"reclaimed"??

* note ripping "down" the contour!

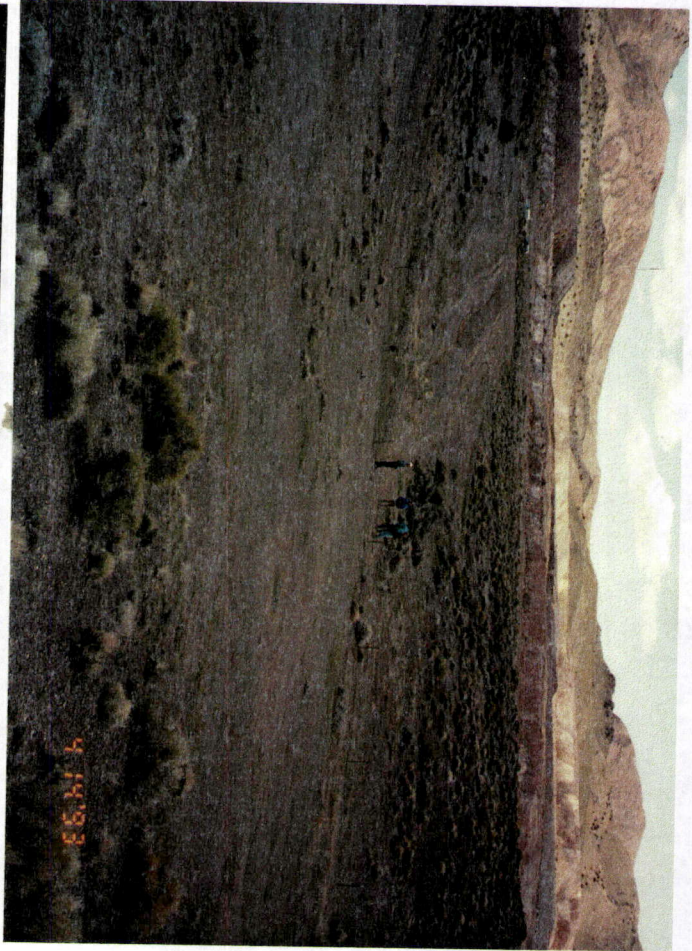
We discussed the shallow perched aquifer system which has shown some cyanide contamination and asked if the proposed cut-off trench had been constructed yet. Mr. Hartshorn stated they had not received clearance from the Division of Water Quality yet. He took us to the proposed location for the interception trench and showed us the series of drill holes (piezometers) which JMC has drilled to help define the extent and gradient of ground water flow for this aquifer. Most of the shallow open drill holes had water in them at the time of our inspection.

" Proposed location for
interception trench "do
drain perched aquifer that
has traces of cyanide present.
(just this side of fence line)
in foreground

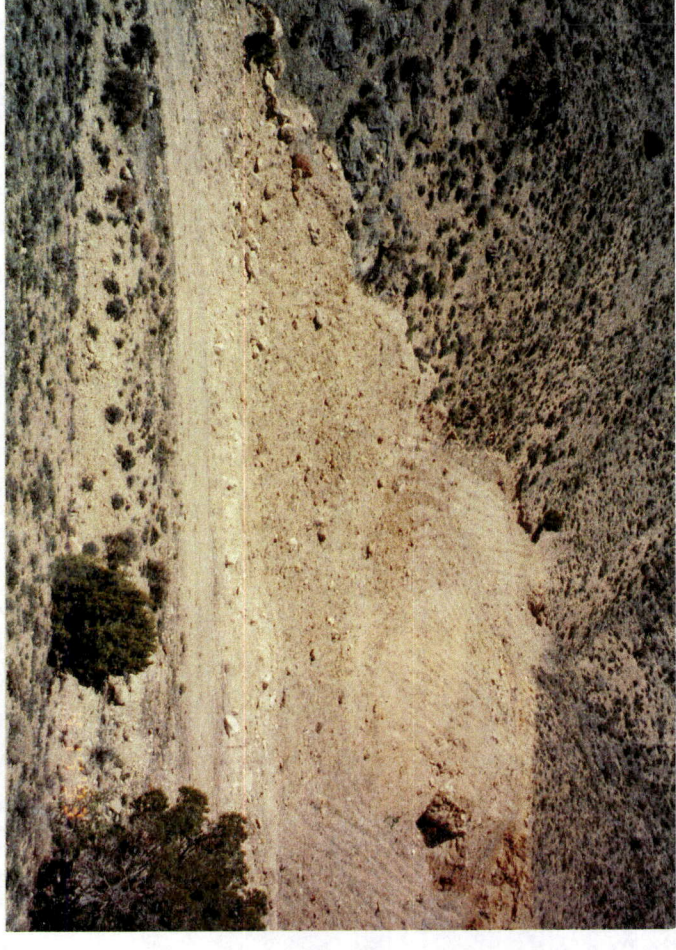
We proceeded on to the Alto pit next. On the way, we stopped to look over a potential topsoil borrow area located approximately 2 miles north(?) of the Drum mine site. It is a lowland area adjacent to the Alto access/haul road and appears to have a significant amount/depth of salvageable soil material accumulated. The Alto site has been partially developed, but mining has been suspended and probably will not resume until the new heap leach pad is approved.

view of possible topsoil
"borrow area"

@ 2 miles North of mine site
along road to Alto pit

* Note below "digger trenches/mounds"

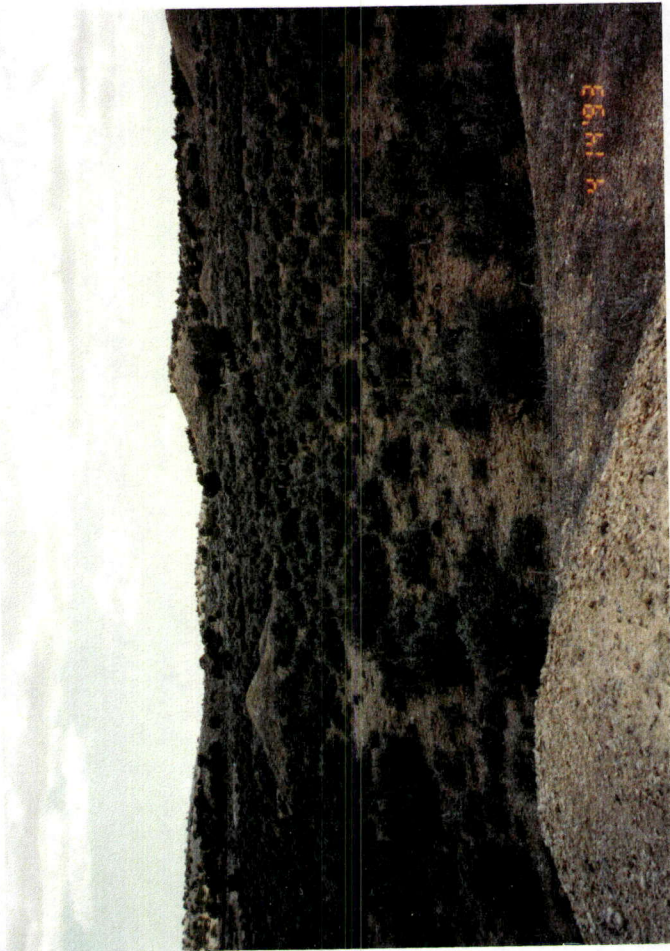
Proposed area for "new" heap leach
pad. (Just left of existing heap)

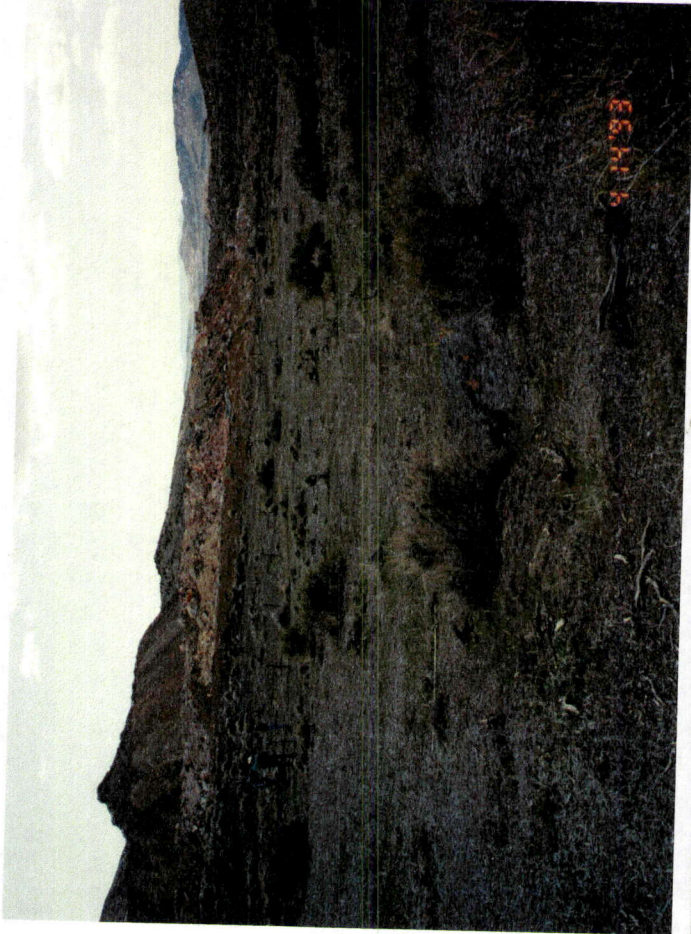
another view (longitudinal) of
proposed location for "
interception trench

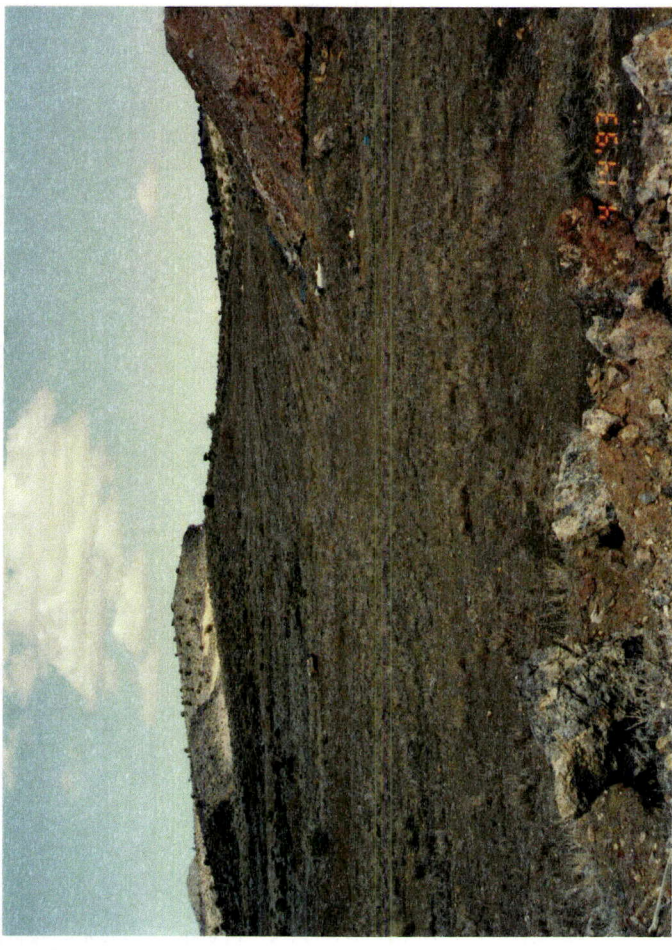
another view of area that could
serve as a topsoil "borrow source"

* Note old gravel "digger trenches/mounds"
in foreground

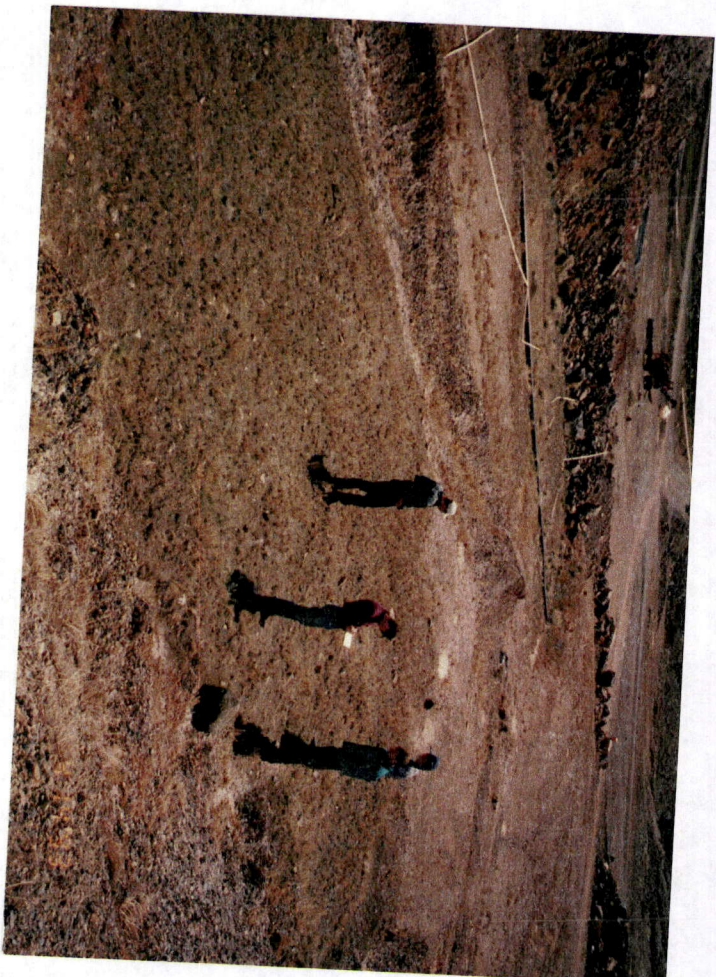
Testplot # 2

Mr. Hartshorn indicated that the second test plot has more recently (within last 2 weeks?) been reworked and reseeded. He has split this plot into 3 separate sections; all have @6 inches topsoil, two sections have been ripped/scarified, 2 sections have also been fertilized, and all were reseeded (broadcast at @20 lbs/acre - seedmix as above). Mr. Hartshorn indicated he has been watering this test plot every 2-3 days. No evidence of seed germination was observed at the time of our inspection.

View from west looking east

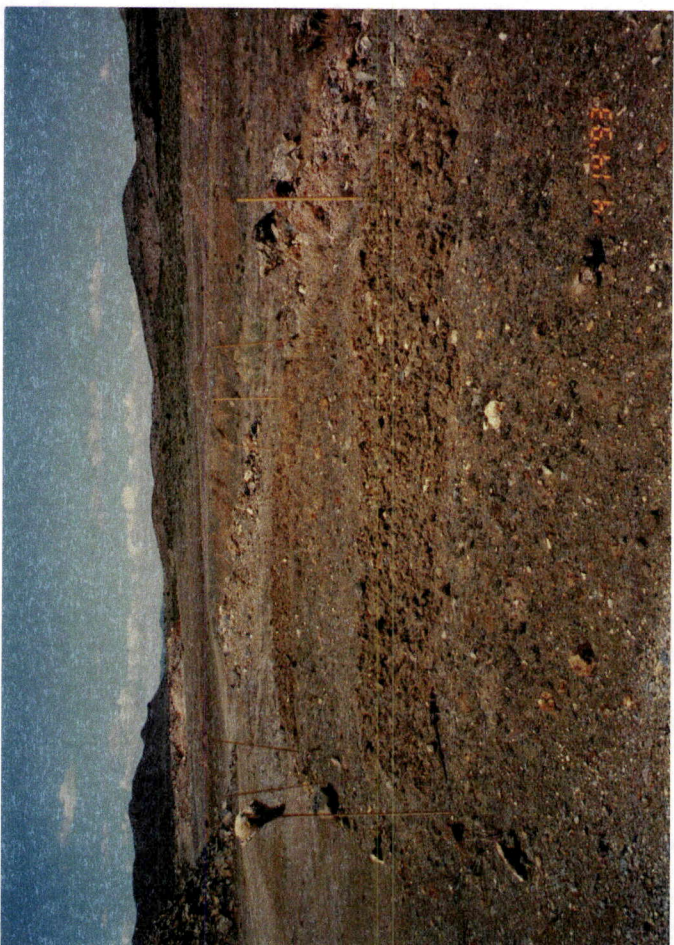
Testplot # 2

View from east looking west

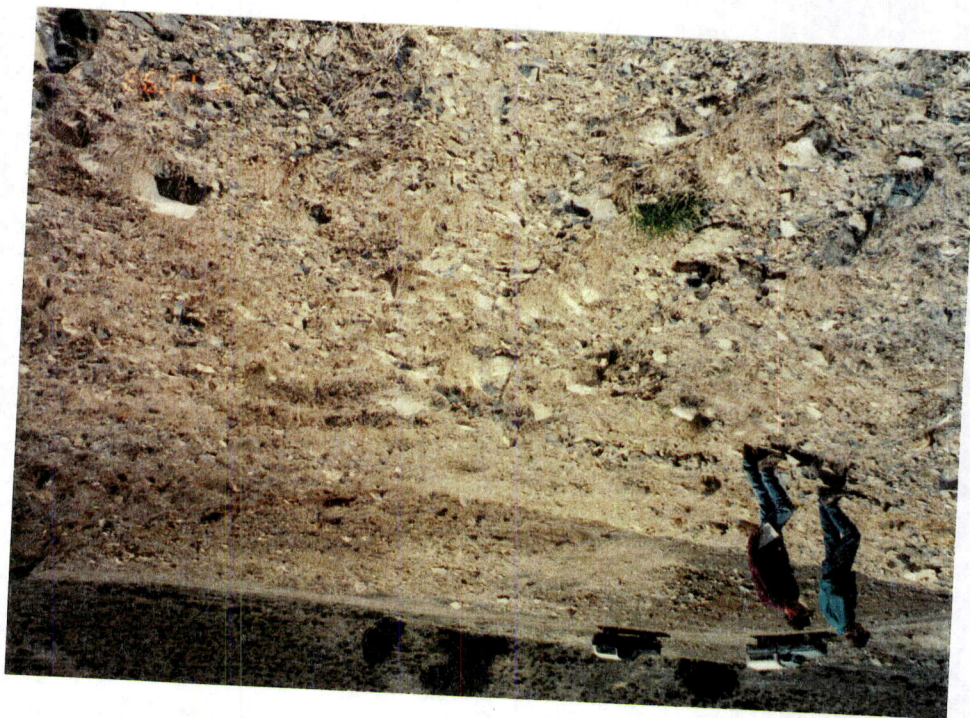
2ndary topsoil stockpile area
just ^{South} west (?) of existing LG#2
heap + adjacent to new reveg
test plots.

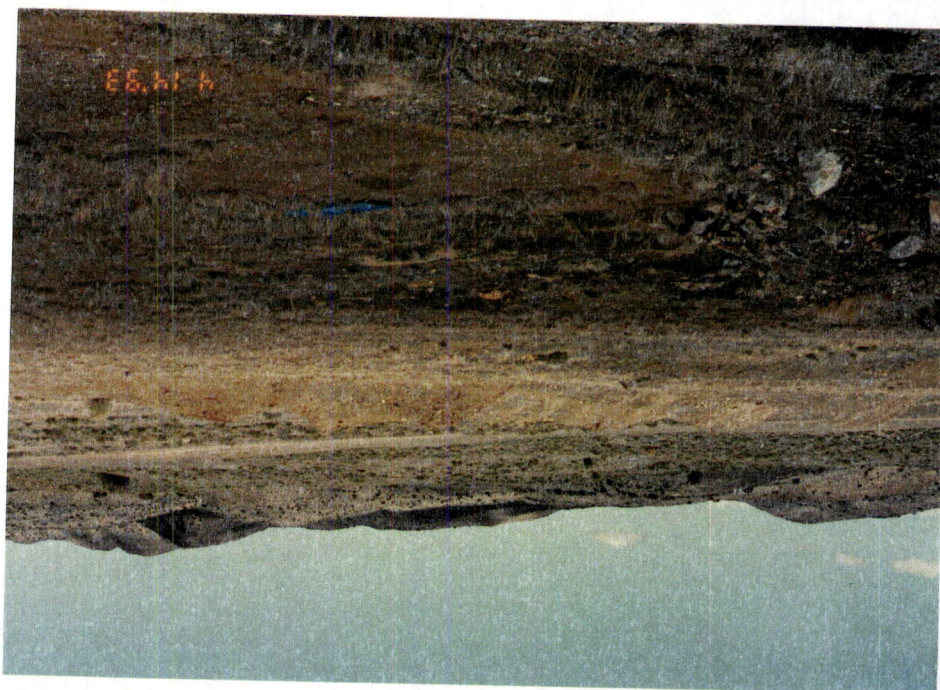
Monarch Pit - Reclaimed?
